OLD TOWN ROCKWALL HISTORIC DISTRICT - *Certificate of Appropriateness - Application*

AGENDA ITEM: H2007-002; 804 N. Goliad Demo

STRUCTURAL & FOUNDATION INSPECTION REPORT

Inspection Address: 804 N. Goliad, Rockwall, Texas 75087 (Mapsco 20C-Z)

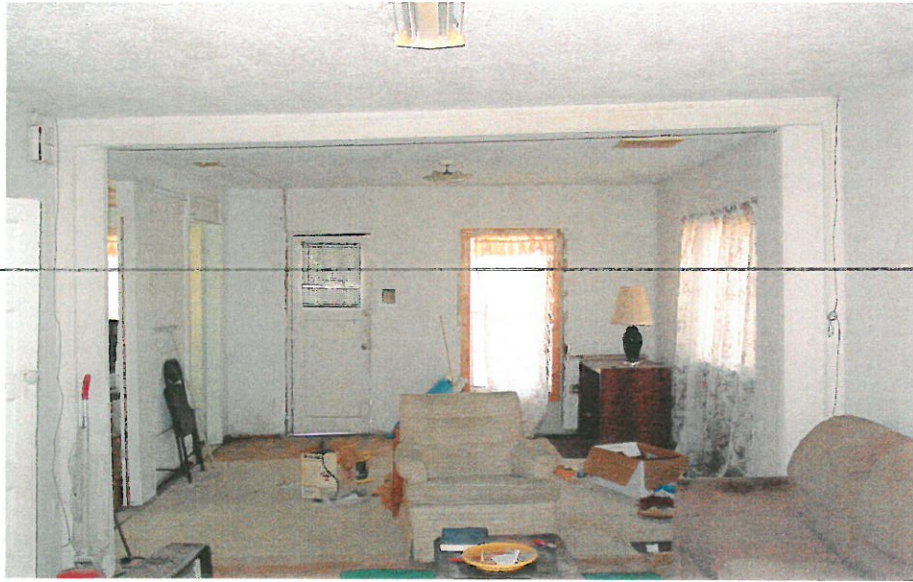
The camera is straight

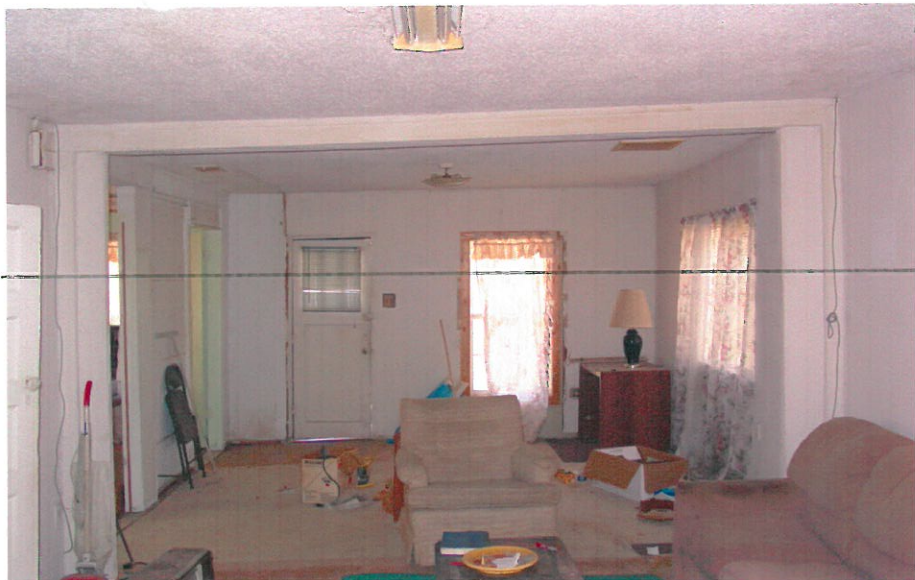
The camera is straight
