OLD TOWN ROCKWALL HISTORIC DISTRICT - *Certificate of Appropriateness - Application*

AGENDA ITEM: H2007-002; 804 N. Goliad Demo

STRUCTURAL & FOUNDATION INSPECTION REPORT

Inspection Address: 804 N. Goliad, Rockwall, Texas 75087 (Mapsco 20C-Z)

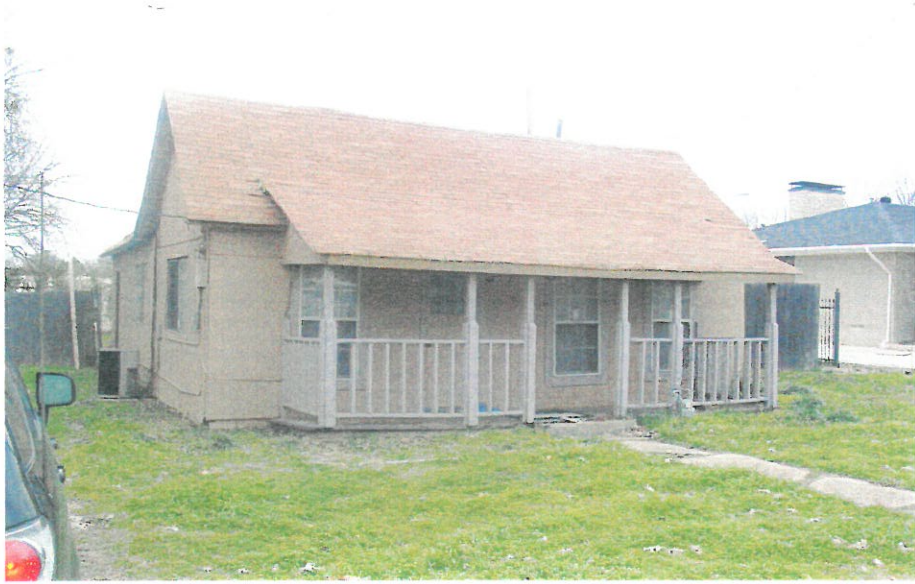
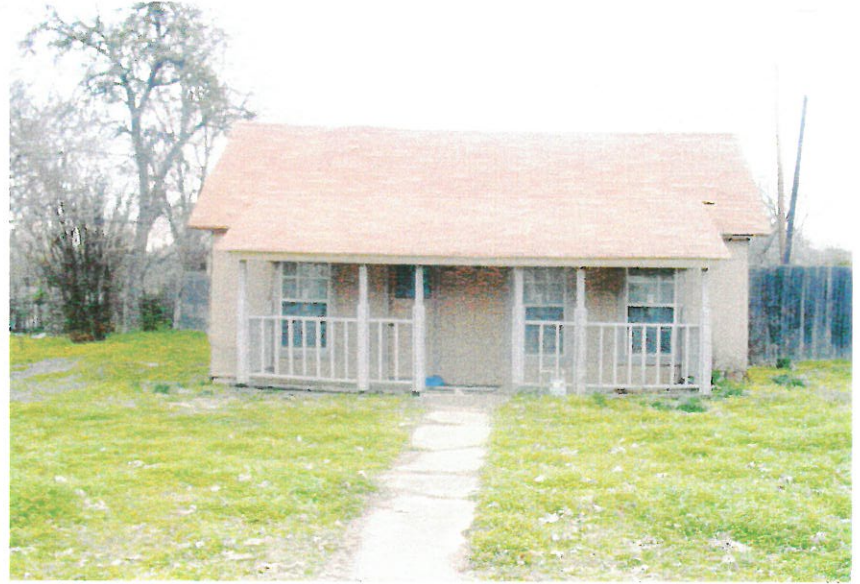
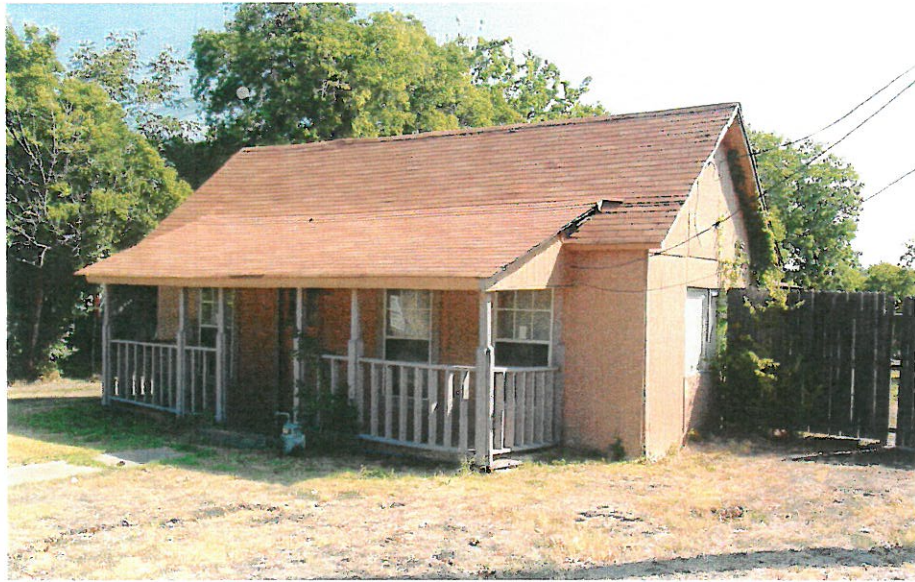
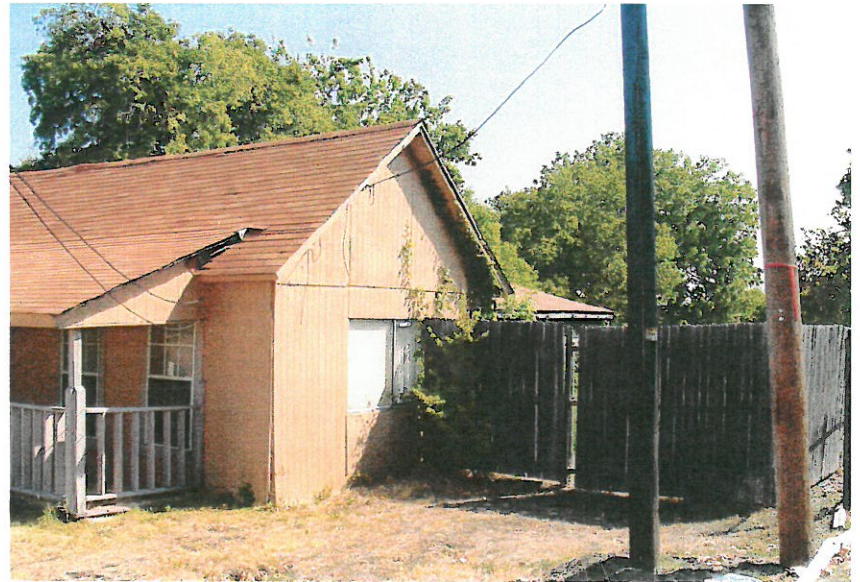
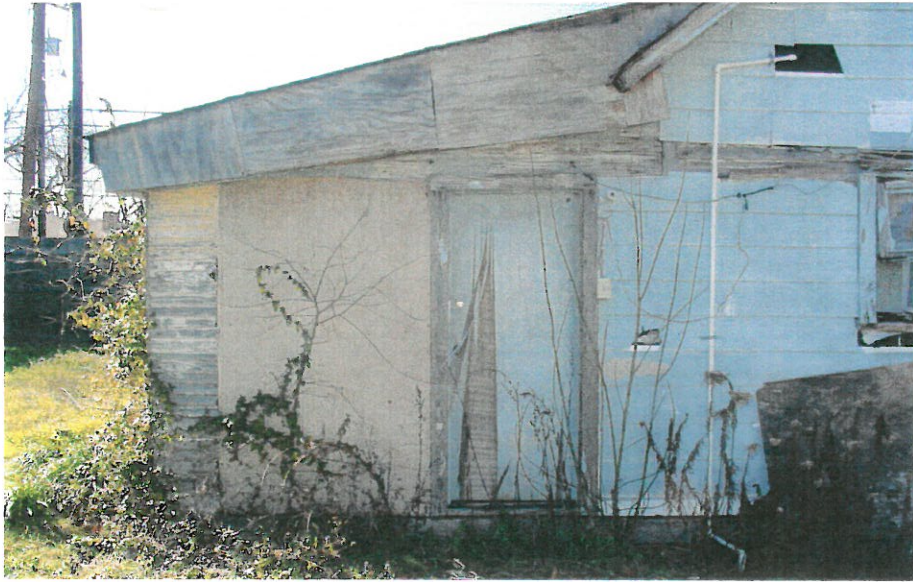
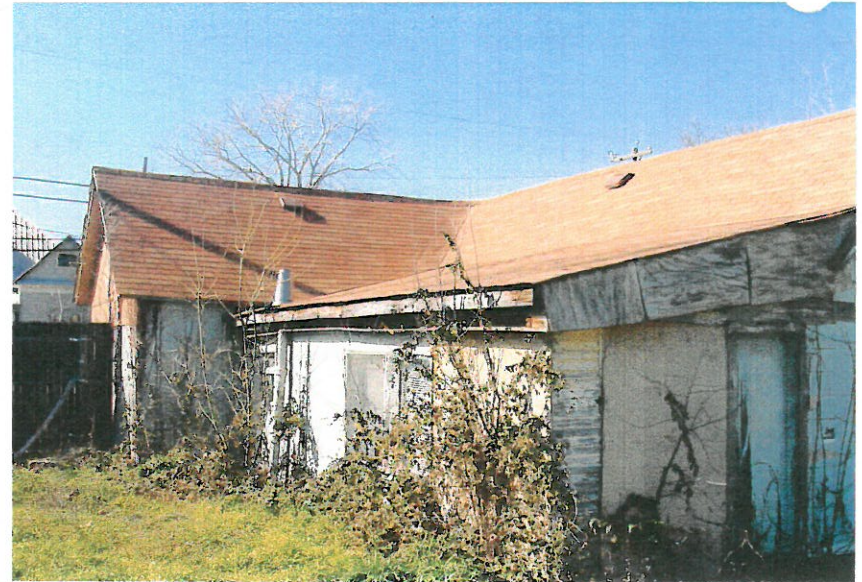
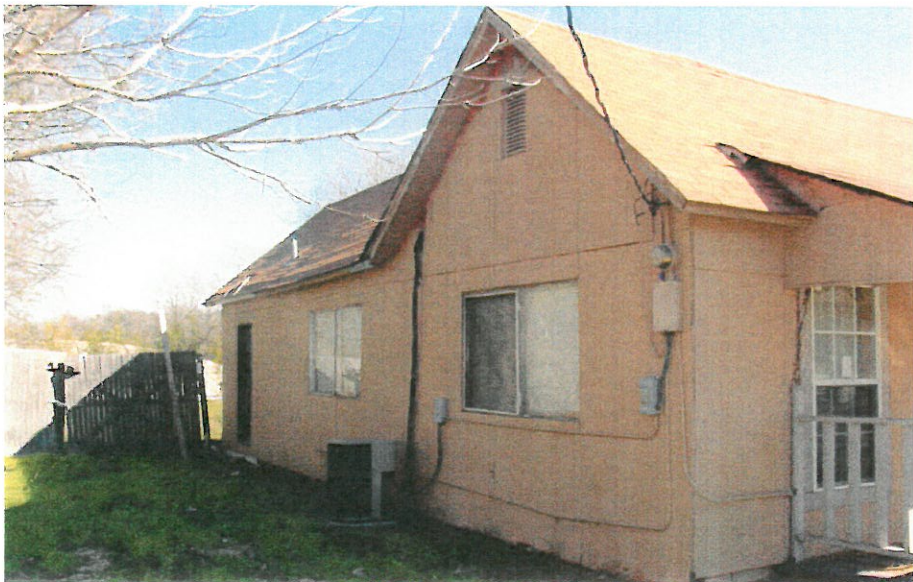
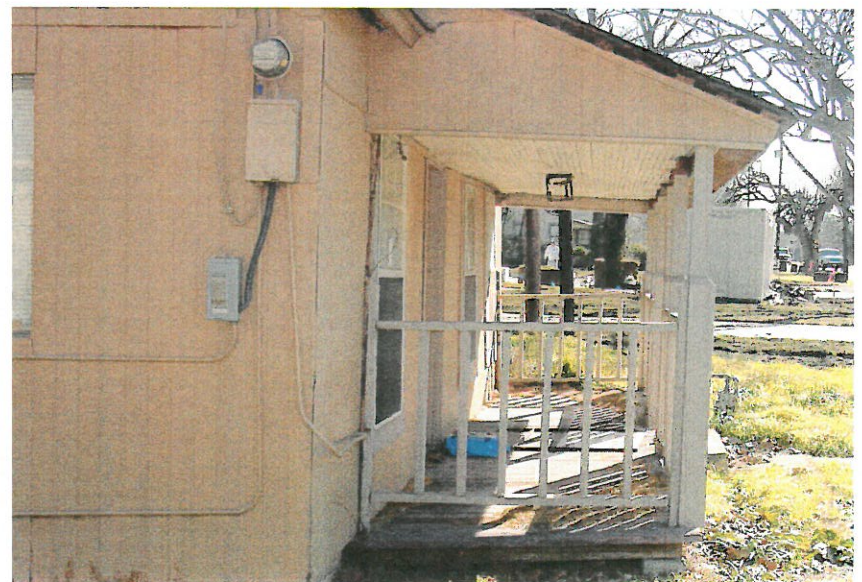
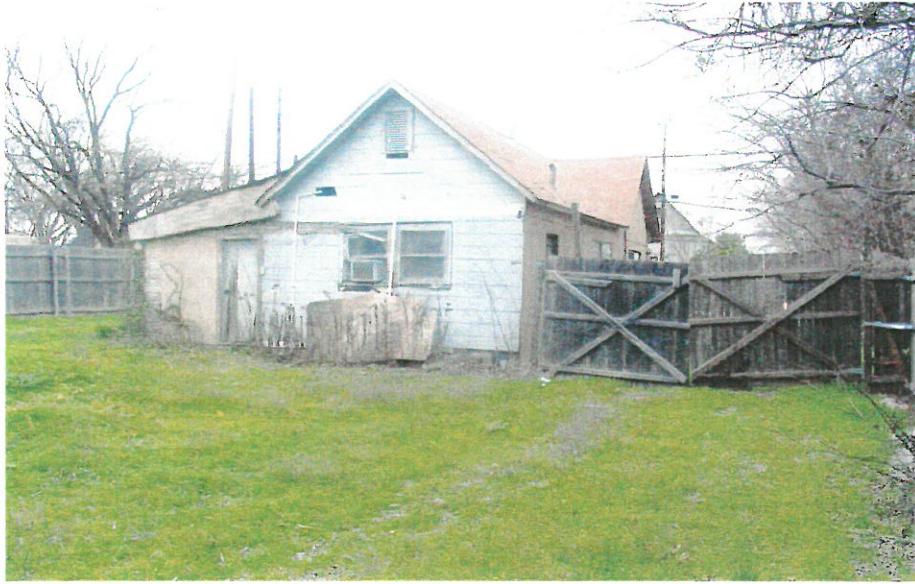
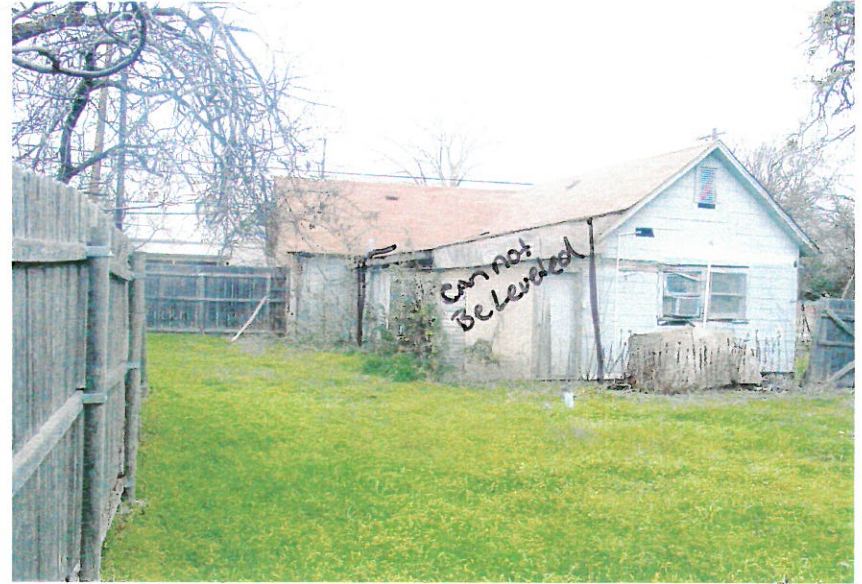
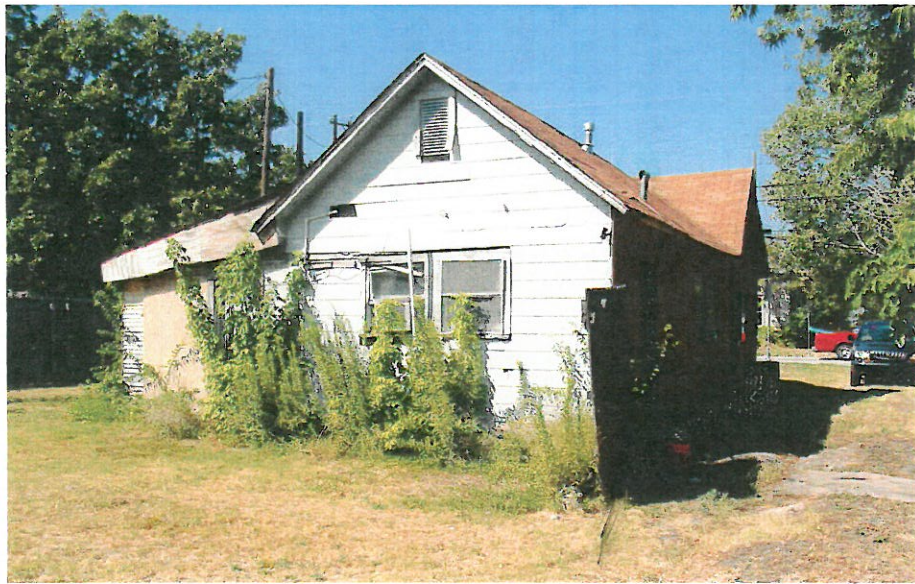
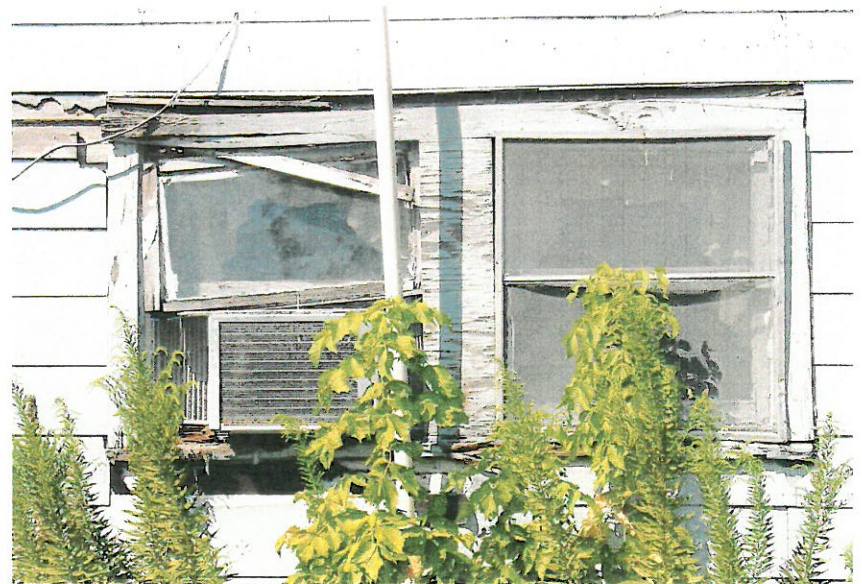
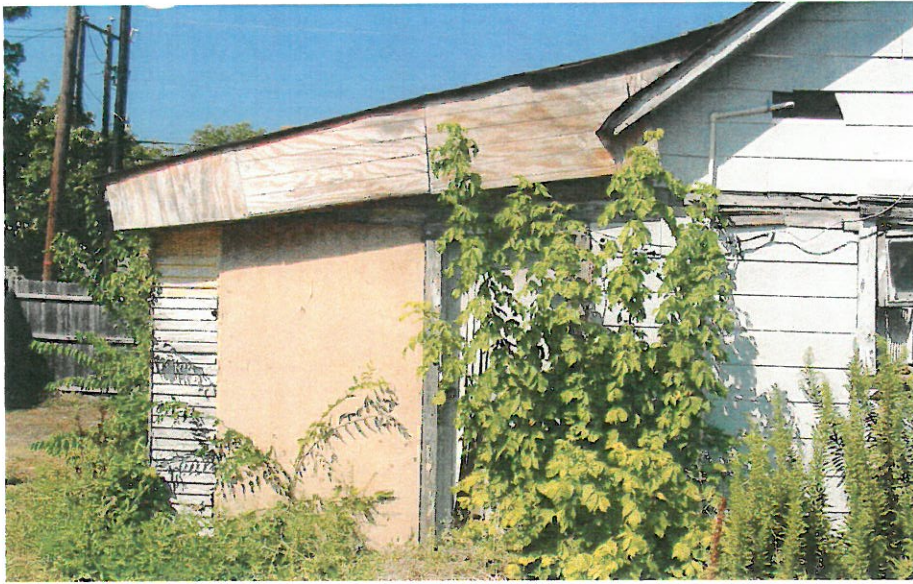
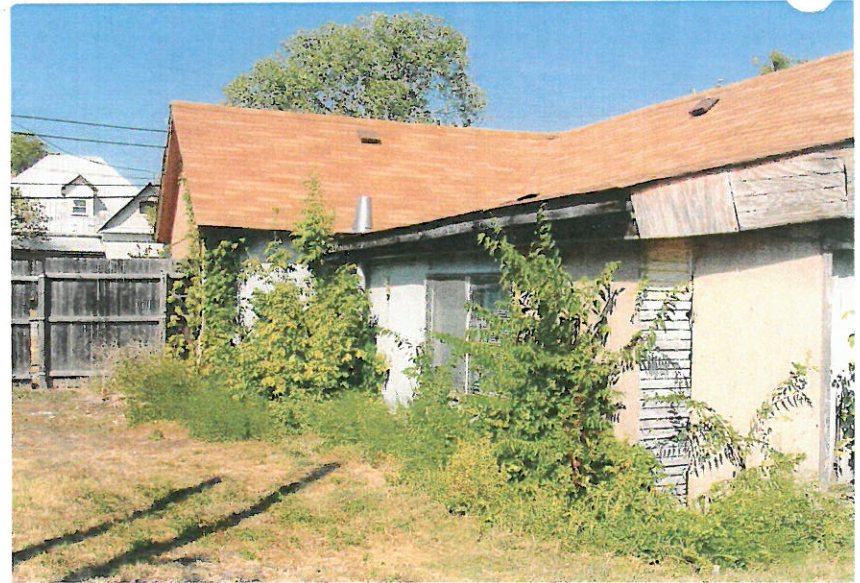
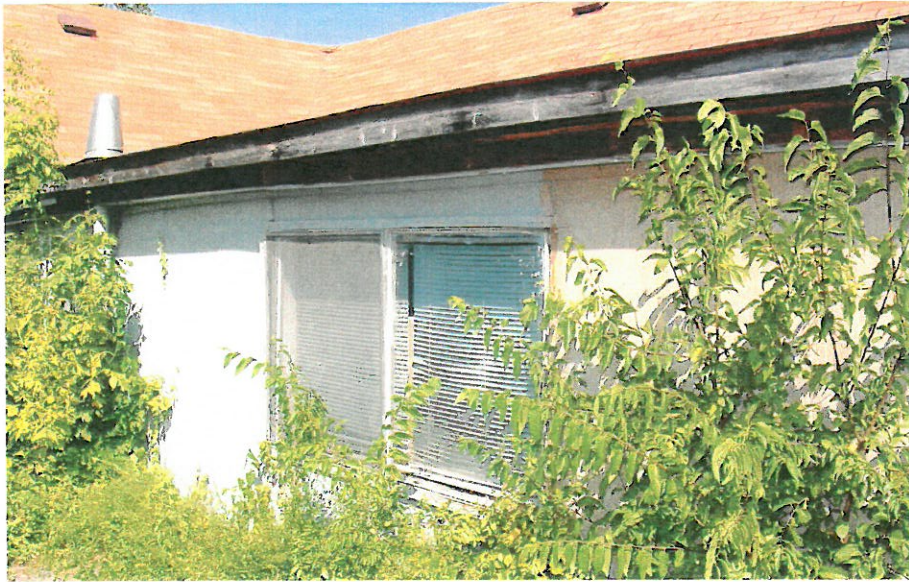
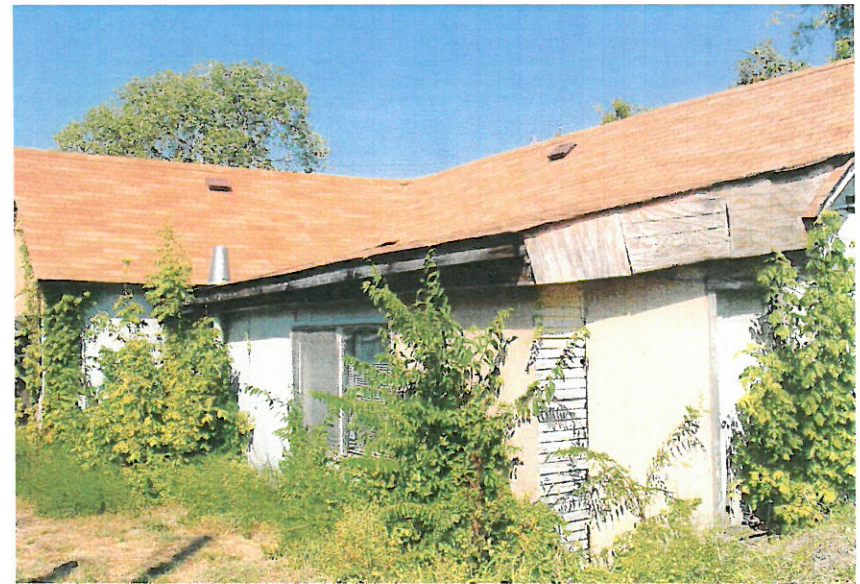
The exterior of the subject property is seems fairly well maintained from North Goliad, however, the pictures of the rear of the house (behind the existing privacy fence) show a neglected and dilapidated house. The photos of the interior provided by the applicant indicate that the property is in need of a great deal of structural repair and there may be some question as to the structural integrity of the property as a whole. The height of the ceiling in several rooms poses another set of issues and concerns regarding safety of potential occupants.

The floor in the front bedroom has sunk under the weight of a waterbed set up by previous tenants. The sinking floor suggests extreme rot of the underlying supports. The living area ceiling and floor slope significantly from North to South. The front door is not operational due to the continual movement of the Structure.

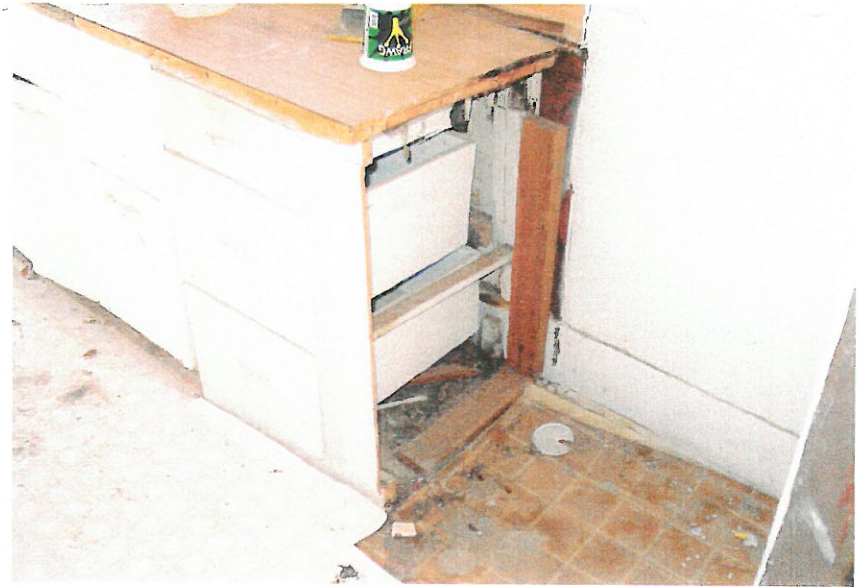
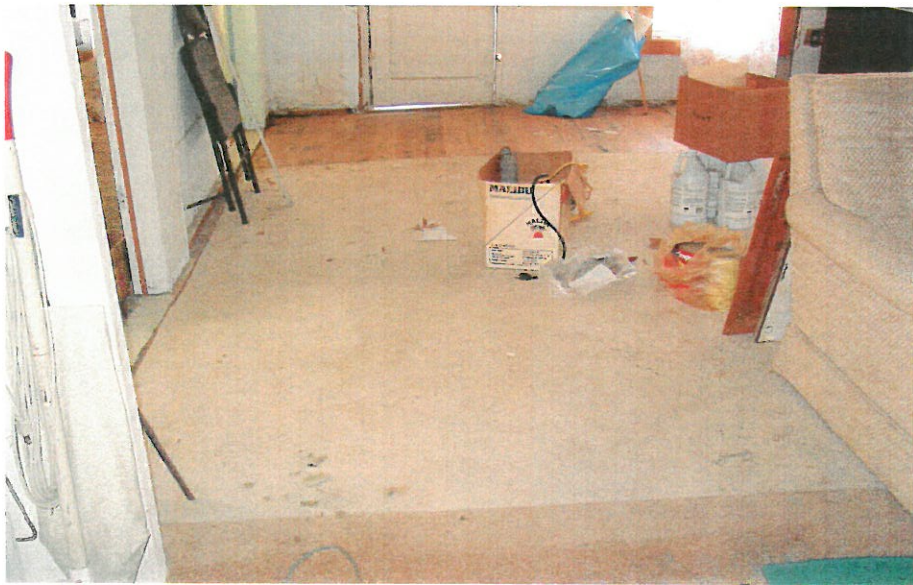
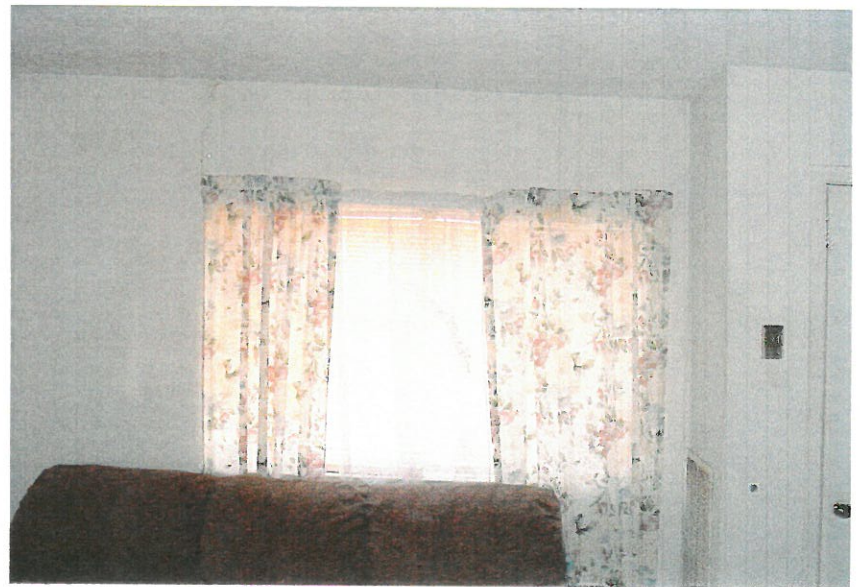
The camera is straight

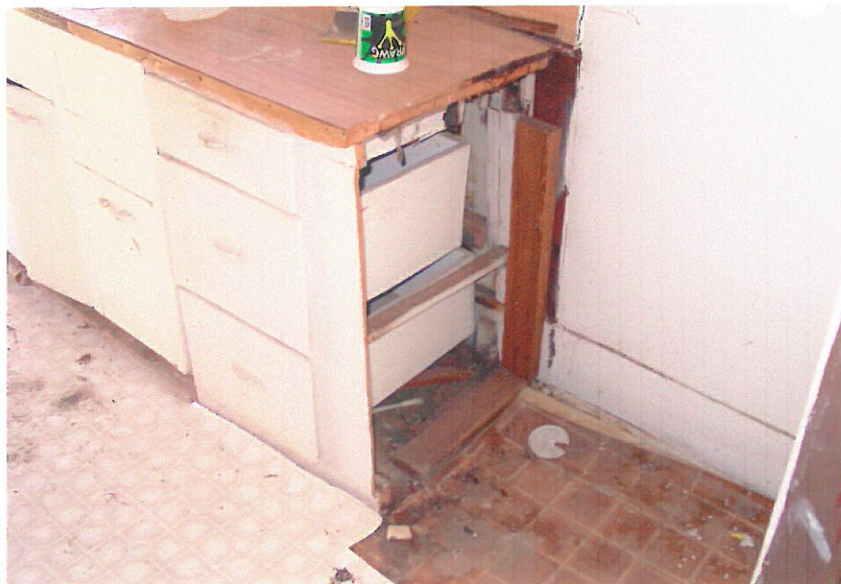
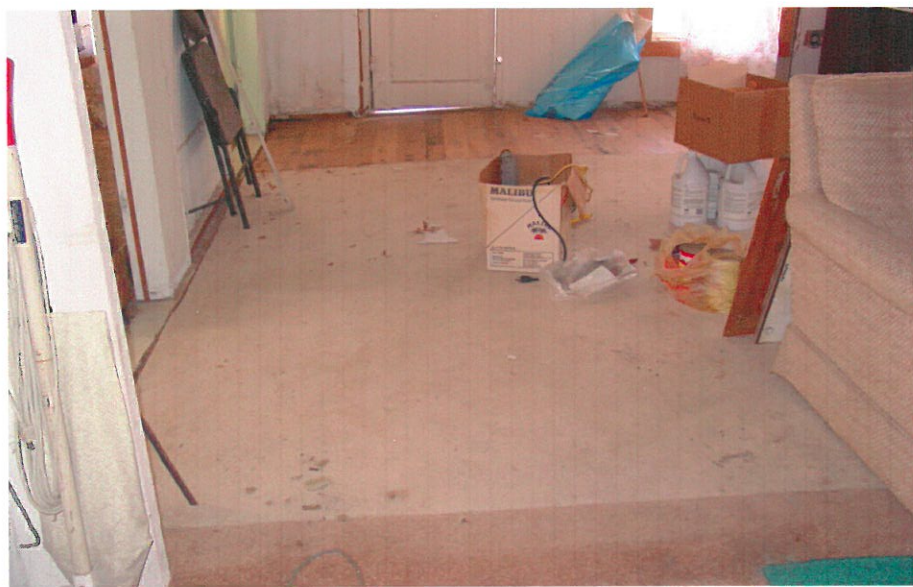
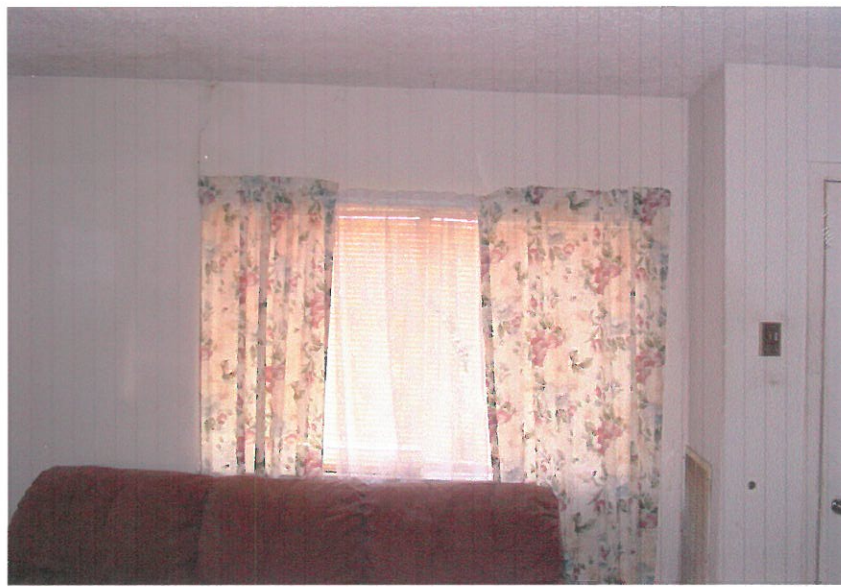
The camera is straight
